**FIREWATER PUMP INSPECTION**

Inspectahire were asked to carry out a CVI (Close Visual Inspection) of the Firewater Pump 3201B on a large offshore platform on behalf of major Oil company. The pump itself was located in the pump room which was under cover. Access to the Pump Discharge Column Internals was facilitated by the removal of a section of the discharge pipework.

**RISER FIREWATER PUMP INSPECTION**

Inspectahire were asked to carry out a CVI (Close Visual Inspection) survey of a Riser Firewater Pump. The Pump Discharge Column External on the North Everest Platform.

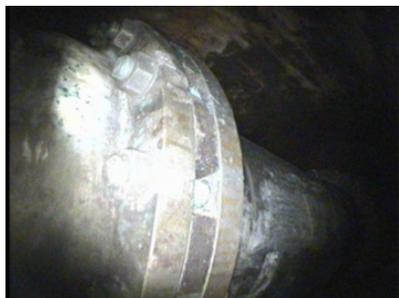
*Flange 2: Appears in good condition everything intact*
