## ROV INSPECTION

## BRENT CHARLIE- SEA WATER TANK INSPECTION

Inspectahire were tasked with carrying out a sea water tank inspection on the Brent Charlie in 2013. The job proposal stated they were to check Column 3 SW tank riser section for blockages and restrictions.

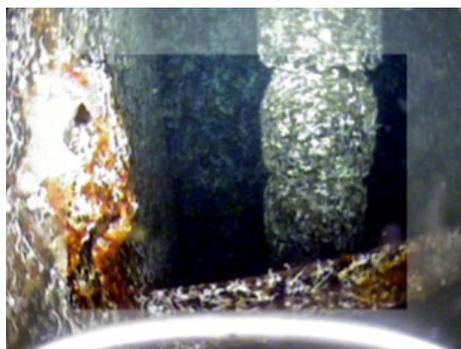
The Sea Water Intake Riser was found to have a covering of marine growth along its length. A considerable amount of marine growth was found to be present on the cross bars at the end of the Intake Riser covering approximately 80% of the opening and continuing back up the riser for 2 meters .

The Sea Water Intake Riser measured 50 meters from the base of the Sea Water Tank. It was not possible to inspect the riser blank repair work done previously or the lower tank section as the base of the tank had a covering of marine growth and debris. Four hessian style sacks/bags and a barrier label were removed prior to the ROV survey.

A small piece of debris proved too awkward to remove with the ROV on one of the strainers. The supporting cross members of the tank were showing signs corrosion along with other smaller metal supports/brackets. The Fire Pump strainer looks to be in clean condition.

The Tank showed a large amount of marine growth and debris, clearly shown by the ROV.
